AFWAL-TR-81-3096

EVALUATION OF SEVERAL BONDING PARAMETERS ON THE RANDOM BENDING FATIGUE LIFE OF ADHESIVELY BONDED ALUMINUM JOINTS

AUGUST 1981

TECHNICAL REPORT AFWAL-TR-81-3096
Final Report for Period June 1978 — November 1980

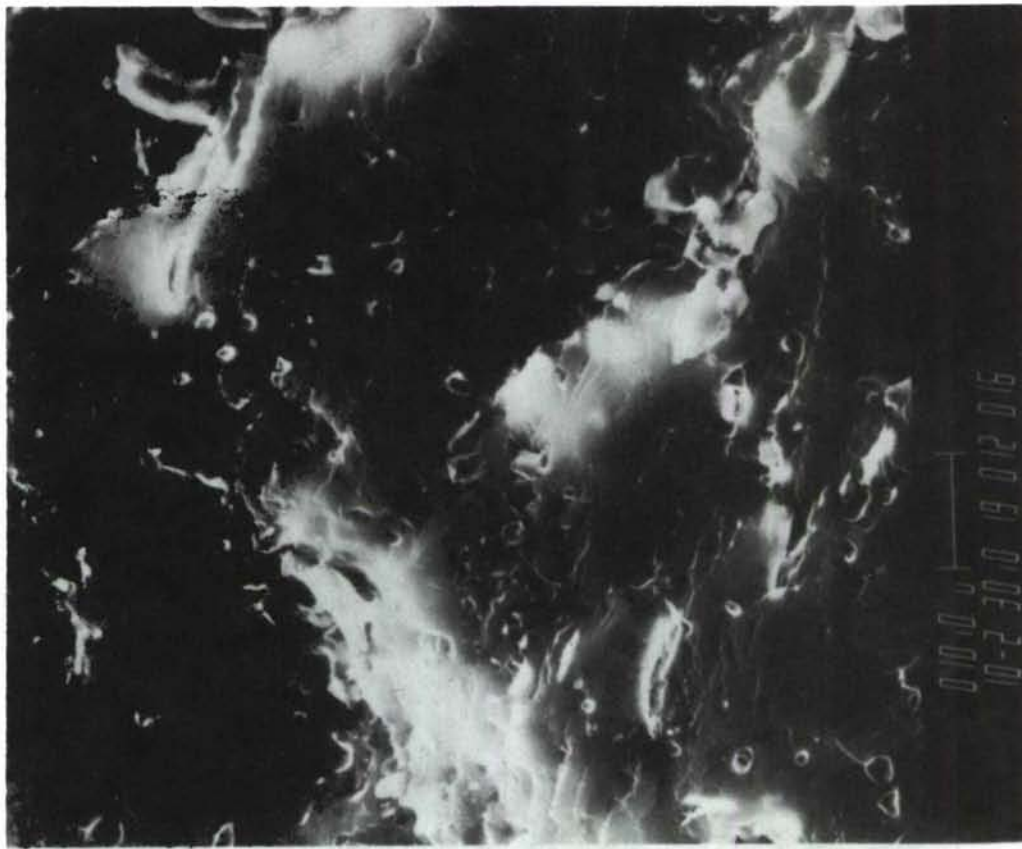
Figure Nr. 20 - Photomicrograph of Fracture Surface (Tee Side), Group B, Specimen Nr. 2

For a representative specimen from Group B (Specimen Nr. 2, the standard PABST system but with a thinner primer than normal), fracture was cohesive within the adhesive, but close to the primer on the skin. This is illustrated by Figure 20 showing the fracture surface of the tee, and Figure 21 showing the fracture surface of the skin, both near the fracture initiation zone. Figure 20 shows the classical cohesive failure mode for FM73, whereas Figure 21 shows the needle-like chromate crystals from the primer under a thin layer of adhesive.

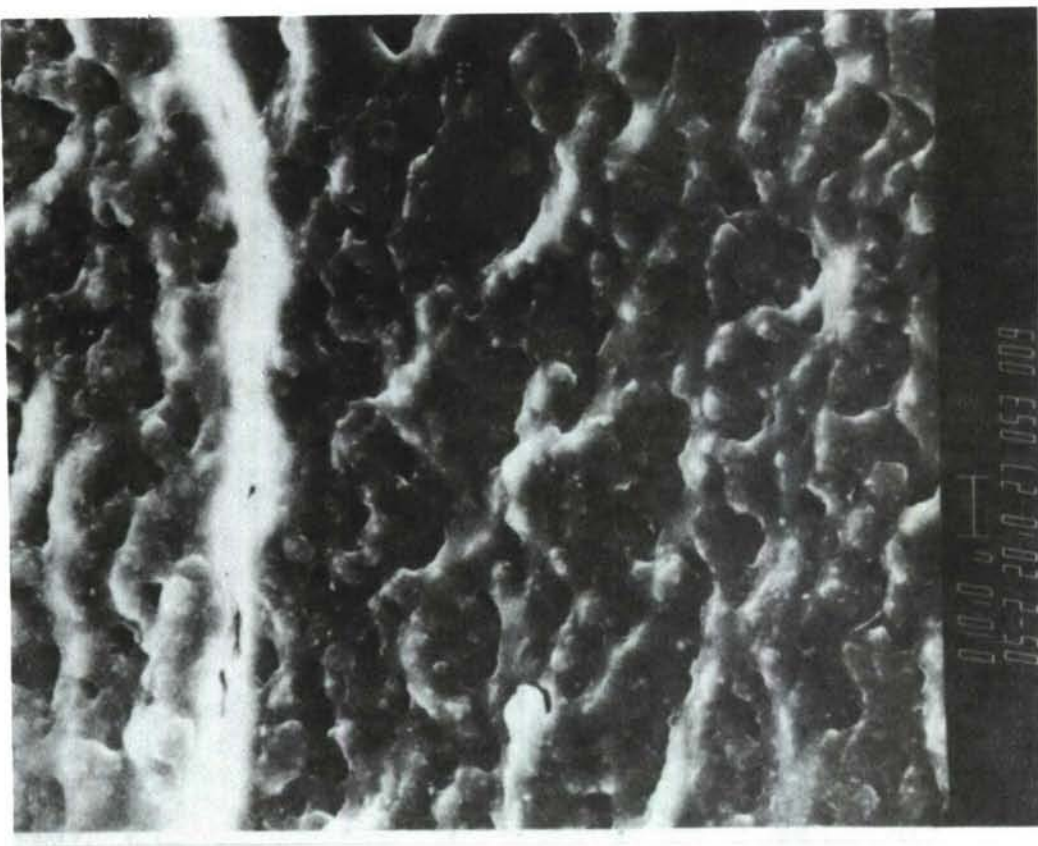
Photomicrographs of the fracture surfaces of a specimen made with AF30 (Group F, Specimen Nr. 3), a nitrile rubber phenolic adhesive, indicated predominantly cohesive fracture, but with a morphology different from that of FM73 adhesive. Figure 30 of the fracture surface of the skin shows a continuous phase which appears to be elastomeric. The elastomeric nature is indicated by local regions of "necked-down" material and the undulating, highly deformed overlapping layers. Figure 31, a photomicrograph of the

Figure Nr. 30 - Photomicrograph of Fracture Surface (Skin Side), Group F, Specimen Nr. 3

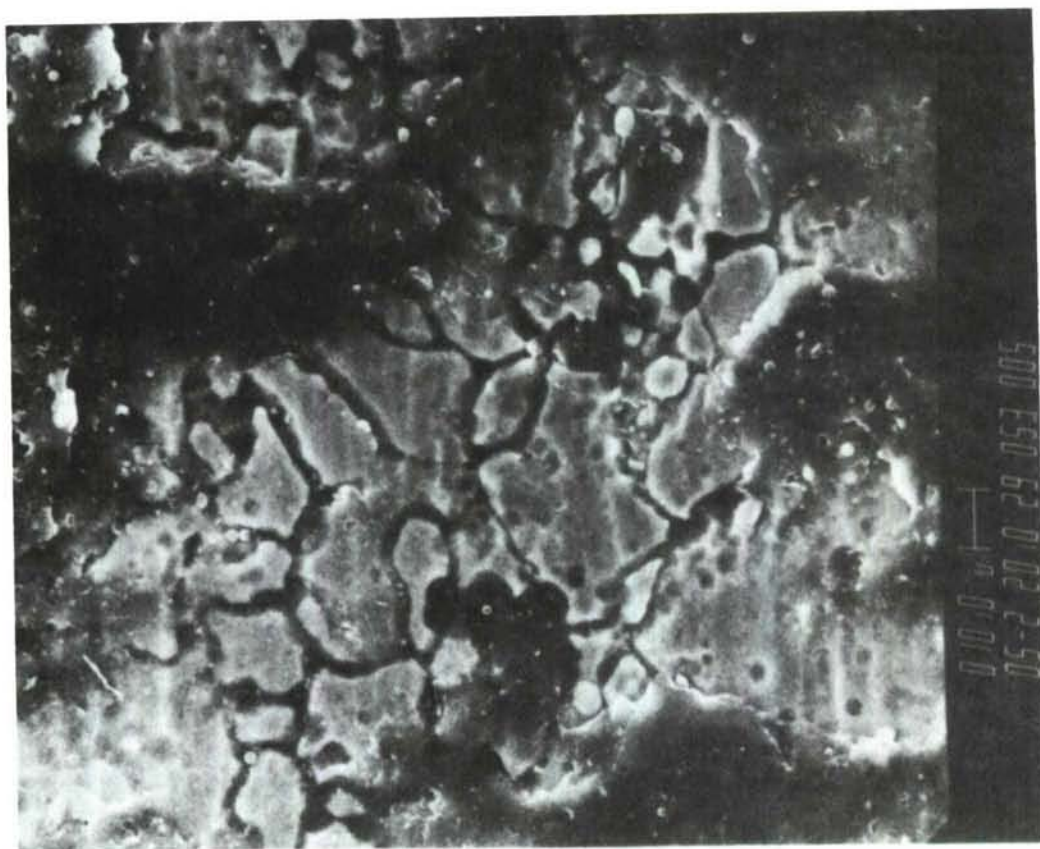
Figure Nr. 32 - Photomicrograph of Flash Area
